Master Thesis, Department of Geosciences

# **Spatial and temporal analysis of Holocene coastal development: applications to erosion assessment and cultural heritage mitigation in Svalbard**

Master Thesis in Geosciences

Discipline: Physical Geography, Hydrology and Geomatics

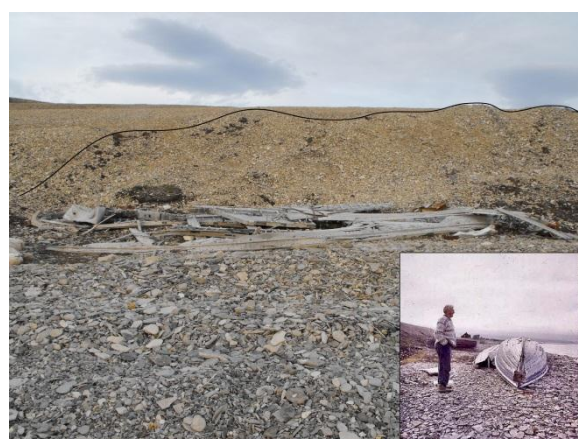
Figure 8: The remains of the crushed boats where the black line indicates the extent of ice floe thrusting as indicating by sediment push (Sessford, August 2012). Inset image of Hilmar Nøis with the boats in 1965 (From archive of John-Eldar Pedersen).

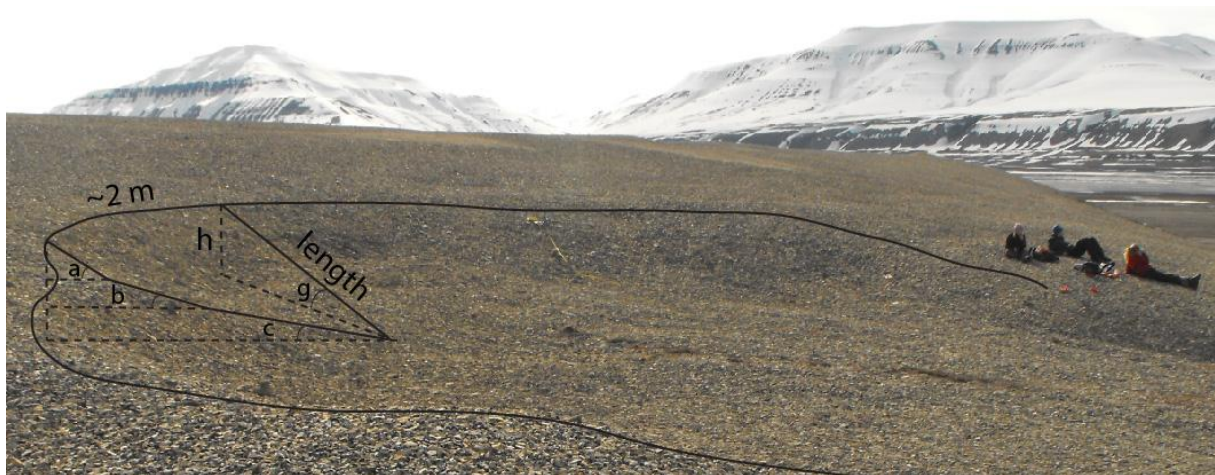
Figure 13: Simplified sketch of active layer detachment slide measurements. The curved black line represents the scarp along the backwall as delineated by the change in angle, and discolouration of beach terrace stones. Slope gradients are a) top, b) middle, c) bottom with the average gradient represented as g). Measurements took place approximately every 2 m along the scarp (Sessford, June 2012).

Active layer detachment slides have been measured at the Fredheim site in an attempt to find the back wall height at the time of detachment. The idea being that the back wall height should give insight into the depth of the active layer at the time of detachment. They have been simplified so that each measurement mimics a right angle triangle in an attempt to reconstruct the back wall height at the time of release using the Pythagorean Theorem (Figure 13). Measurements were taken every two metres along the back wall. The length of the hypotenuse along the slope of the slide has been measured using a cloth tape measure, and the gradient of the back wall slope measured using a hand held compass at the top, middle, and base to find an average gradient. The base of the slope is considered to be at a  $10^\circ$  gradient. As most of the slides have post-detachment gelifluction on their surface, it is difficult to determine where the base of the detachment is located. All measurements are found in the appendix section of this thesis.

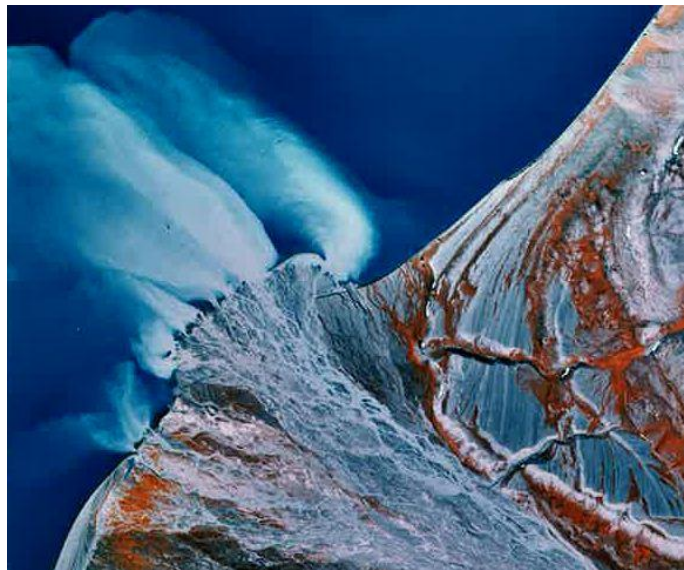
Figure 4: Fluvially dominated sedimentation affected by longshore drift and fjord circulation at Fredheim. (Aerial Image S90, Norsk Polarinstitut, 1990)

The present day shore at Fredheim is made up of a beach and deltaic system with sediment deposition dominated by fluvial and wave (longshore drift) energy (Figure 4). It is considered a soft, weakly consolidated and easily erodible coast as described by Fairbridge (2004). The system acts as an analogue for past Holocene landform development. Beach sediments are clast dominated by mostly well rounded plates. The delta is made up of well-rounded clasts and sand that have been fluvially transported, less sorted than the beach deposits. The delta is prograding northward into Sassenfjorden and eastward along the shore due to longshore drift and is easily distinguishable due to the beach ridges formed during movement. It has grown 189,47m along the coastline at an average rate of 5,92m/yr between 1977 and 2009 (Guegan et al., submitted). Pits are formed on the delta and beach from sea ice and icebergs that have been thrust onshore and/or by the ice foot (henceforth referred to as shore ice if all three ice types are discussed) (Caline, 2010; Rodzik, 2009; Nichols, 1961). The ice foot as described by Caline (2010) is a fringe of ice attached to and along the shore and may be of varied widths. It is especially of interest in regards to its role in shore erosion and sediment transport as discussed further in (Guegan et al., submitted; Allard et al., 1998). The ablation of shore ice is unevenly distributed and causes the creation of ice tumuli overlain by gravel deposits that produce pitted beaches as ice thaws out (Rodzik, 2009; Nichols, 1961). Both pits and beach ridges appear on the present day shore. Within the delta there is a lagoon which is changing in shape, size and outflow location on a yearly basis (field observations and DGPS measurements, this study) and can be observed through aerial image analysis from photos taken in 1977, 1990, 1995 and 2009 (Norwegian Polar Institute, aerial image depository) (Guegan et al., submitted).

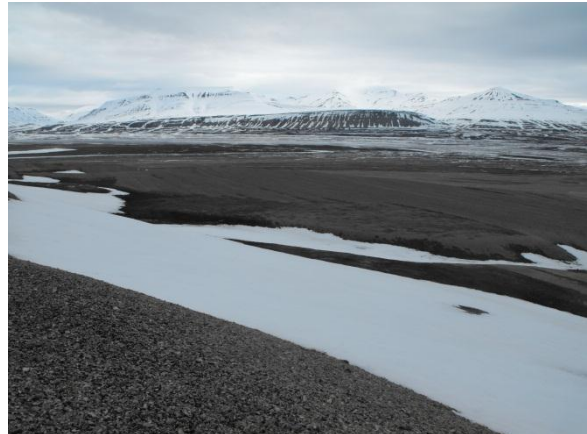
Figure 5: Beach ridges on MT3, note linearity and spacing. Image taken from the northeast of the map facing south west, Nordbekken can be seen in the bottom right corner of the photo. (Sessford, 2012)

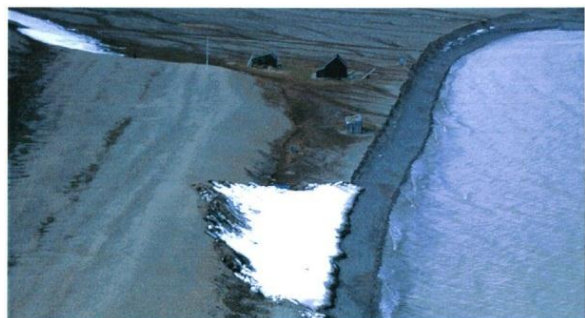
Figure 6: Ice ride up/pile up from 1999 (Image from Sysselmannen på Svalbard, 2000)

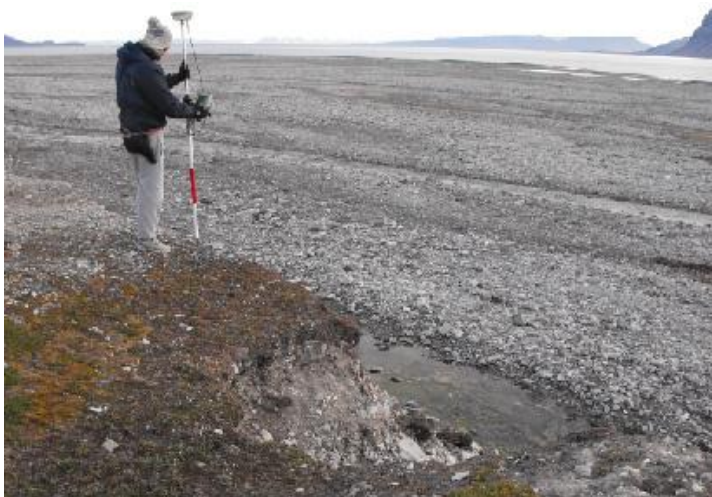
Figure 11 (left): Strong backcutting and erosion where relict channels meet the coastal escarpment due to concentrated groundwater flow (note groundwater at base of escarpment) (Sessford, August 2011)

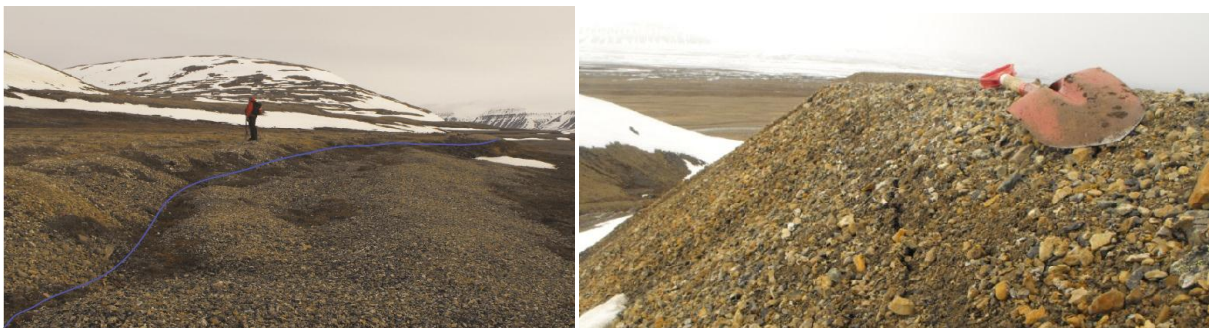
Figure 12 (left): Examples of a gelifluction lobe where the line indicates the front lip (Sessford, June 2012)

Figure 13 (right): Non-vegetated area on the slope of MT3 consisting of colluvium. The shovel shows the boundary between the present day surface and colluvium. At this particular location (nearby to the radiocarbon sample), one can see cracking where the initialization of a possible slope failure may occur in the future. (Sessford, October 2011).

Solifluction is a product of two mechanisms; gelifluction, thaw induced saturated flow of sediments, and creep, frost heave followed by thaw settlement (Matsumoto, 2002). It is a common feature found on Svalbard's slopes. The majority of movement at Fredheim is undergone in well saturated sediments containing excessive vegetation. Therefore, solifluction on the map has been labeled as gelifluction (light orange). The beach ridges on the marine terraces do not contain enough fines and are well drained and therefore less subject to gelifluction, even though the terraces have a slight gradient. The general trend at Fredheim is that gelifluction creeps downslope through two-sided freezing inducing plug-like flow and thereby dislocating the surface layer and creating lobes (Matsuoka, 2001). At Fredheim, lobes are found on steeper slope gradients, tend to be between 0,1 and 0,5 m in height, have a steep front lip and a slight depression toward the slope. The front lip may be either turf-banked (vegetated) or stone-banked (Matsuoka, 2001). However, in some places gelifluction accumulations can produce large gelifluction sheets or terraces such as above MT4 and MT5 where a large section of active layer made up of many smaller gelifluction lobes moves as 'one' piece forming a long, distinctive front lip (Matsuoka, 2001) (Figure 12).

On this map, colluvium refers to loose clasts and sediments that are originally a part of the beach terrace surfaces but are now on the sides of the slopes due to erosion (Figure 13).

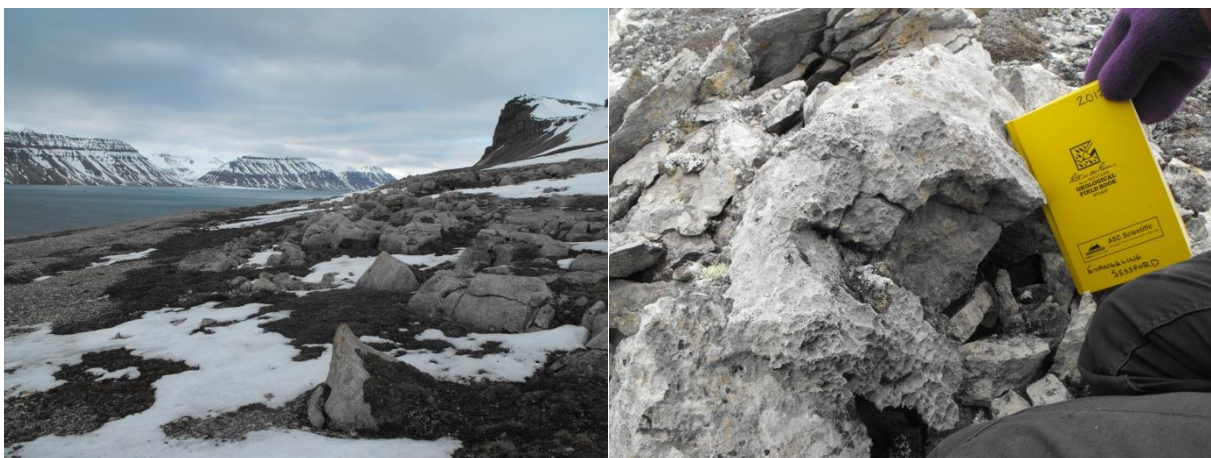
Figure 14 (left): Bedrock exposure on MT3, note well rounded-ness (Sessford, June 2012)

Figure 15 (right): Mechanical (wind) and chemically eroded boulders that have undergone frost shatter (Sessford, June 2012)

to have been heavily eroded by water both chemically and mechanically (Figure 14). However, it is clear that the rock has been exposed to the elements for much longer than the present day cliff as wind erosion has also made its mark by creating facets on exposed surfaces, and frost shatter has downsized boulders (Figure 15).

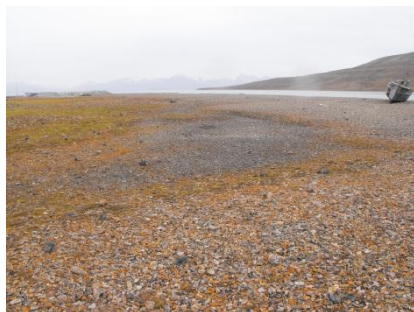
Figure 24 (above): Seasonal pond, note steep gradient toward coast and lack of vegetation (Sessford, August 2011).

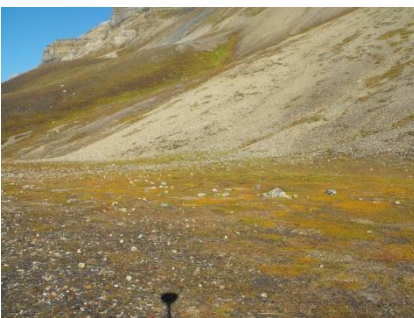
Figure 25 (above): Vegetated beach and colluvial sediments, note rock fall material lying on surface (Sessford, August 2011).

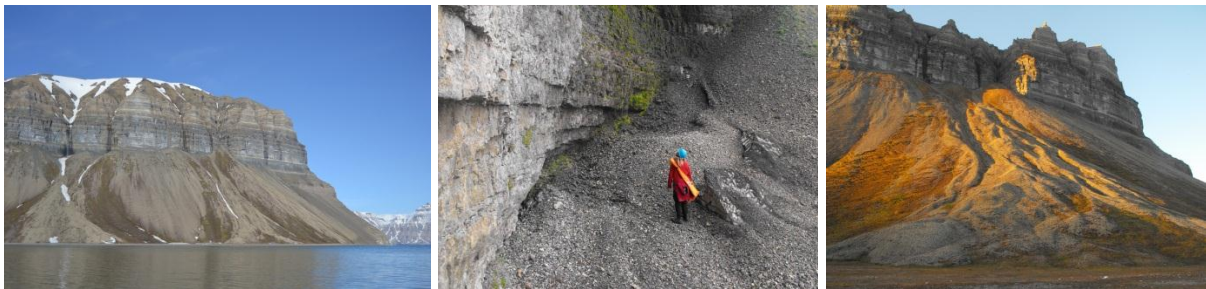
Figure 28 (above left): Skansbukta slopes from the bay, note the rapid mass movement deposit in the middle of two debris flow accumulations (Hassberg, June 2012)

Figure 29 (above centre): Rock fall accumulation at the base of gully below cliff and above debris flow run-out (Sessford, August 2011).

The slopes at Skansbukta are made up of a number of different landforms the main components of which are rapid mass movement, rock fall, debris flow and snow avalanche deposits (Figure 28). Frost shattering within gully systems induces rock fall which collects at the base of the cliff in accumulation zones (Figure 29). At some point these accumulation zones are flushed out by an extreme event such as oversaturation and create debris flows. Debris flows are marked in red on the map and are characterized by very coarse, well compacted and stable angular clasts. They are deposited as elongated mounds or lobes and originate from chute like erosional gullies on the cliffs which are marked by gully edges on the map. These can be identified by their convex shape, lobe divisions, levees and steeper gradients in the upper regions, and spread out low gradient lower regions. It is likely that avalanche deposits co-exist with debris flow deposits but distinctions between the two is difficult on these particular deposits without direct observations (Eckerstorfer et al., 2012). Lobes represent different debris flow events and are marked out as lobe divisions (Figure 30). None of the lobes have been examined to gain understanding of event timing. However, it can be assumed that those on the surface are younger than those that are overridden because of their geomorphological relationship. Snow avalanche deposits and debris flows tend to originate from a confined area and spread out horizontally as they move downslope. Smaller, finer grained debris flows are present on the rapid mass movement deposits and are marked as black arrows. These seem to be more frequent and do not have long life preservation due to their small size and activity of rock fall and gelifluction which override them easily.

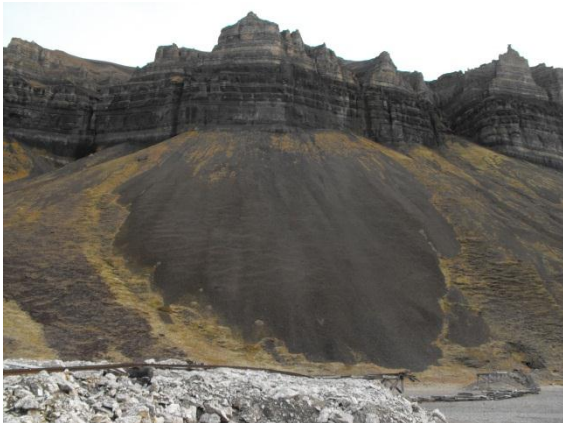
Figure 31 (above): Rapid mass movement deposit showing less active rock fall on the left where gelifluction is the more predominant slope movement, and the right side where rock fall is predominantly active (Sessford, September 2011).

middle of the map is made up of angular, blocky clasts of varying size but mainly in the pebble to small boulder range. Little to no gelifluction movement is indicative of active rock fall and rapid mass movement in the southeastern part of the accumulation. Whereas gelifluction in coarse material, shown as thin diagonal orange stripes is more active in the northwestern section of the map unit. You can also see in Figure 31, that there are some relict fan sections that are becoming covered by thin vegetation.

There are two types of gelifluction in Skansbukta. The first has already been mentioned and is only present on the rapid mass movement (Figure 31). The second is turf banked gelifluction lobes which are located in vegetated slopes and shown as a light orange colour on the map. Steps are between 0,1 and 0,5 m in height and have a front lip and a small depression on the slope side as described in the Fredheim map description. At Skansbukta, gelifluction lobes act as debris catchers during rock fall (Figure 32).

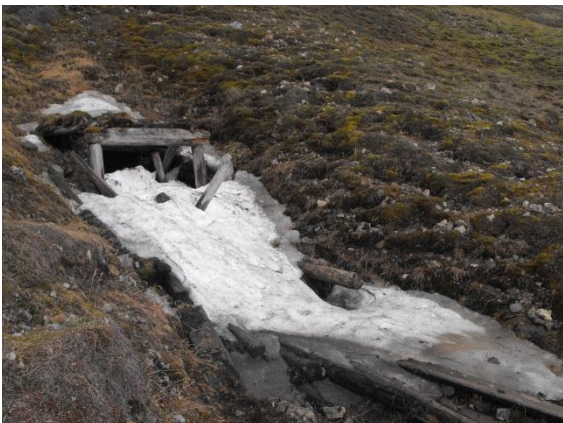
Figure 32 (above): Gelifluction steps to the side and above mine entrance. Note how rock fall is caught on the surface of each step (Sessford, June 2012).

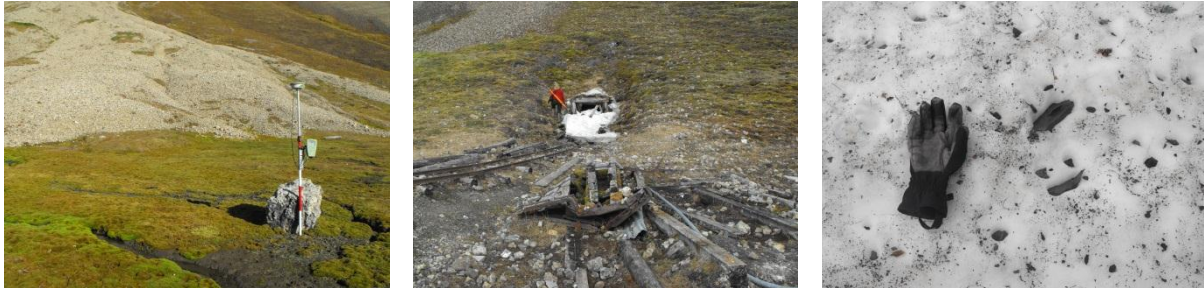
Figure 33 (above left): Large rock fall boulder stopped in bog area (Sessford, August 2011).

Figure 34 (above centre): Rock fall debris come to stop on gelifluction steps, vegetation and cultural heritage material at mine entrance (Sessford, June 2012).

vegetation, either on the slopes where there are gelifluction steps, or at the base of the slope which absorbs rock fall energy thereby slowing the rocks so that they come to a stop sooner (Figure 34) (Jones et al., 2000; Ritchie, 1963). It is quite probable that most rocks extending to the recent beach material have been moved there due to anthropogenic activity. Most of the rock fall is in fact quite small as seen in Figure 35, and there is much occurring in the spring or melting seasons which is caught on snow patch surfaces (Figure 35). It is also possible that much of the smaller debris is aeolian material.

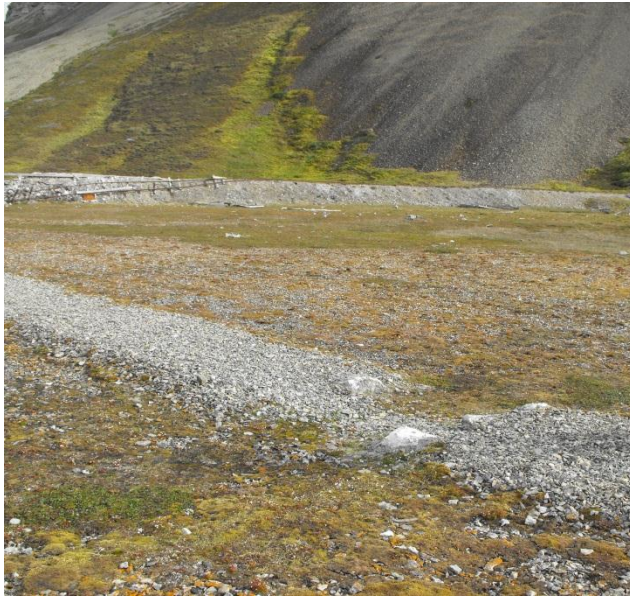
**Figure 38: Man made path with small drainage opening (Sessford, July 2011).**

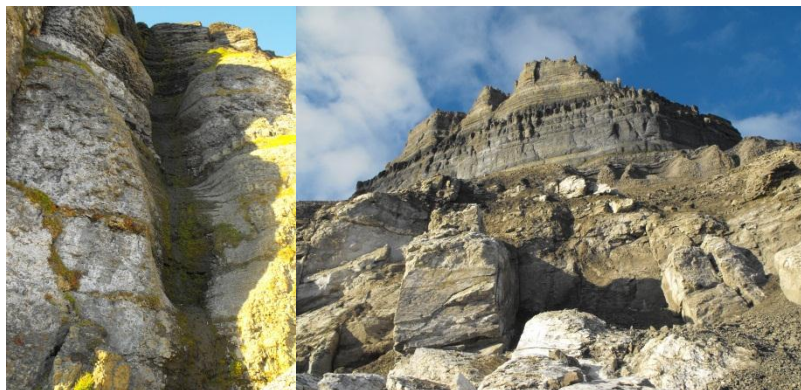
Figure 40 (far right): Lowermost bedrock of the Gipshuken Fm. upper cliff exposures of the Kapp Starostin Fm., both showing autochthonous weathering (Sessford, August 2011).

Autochthonous bedrock weathering is present on all exposed bedrock surfaces. The photo (Figure 40) is taken from outside the map area in the southeast and looking back toward the cliffs above Skansbukta.

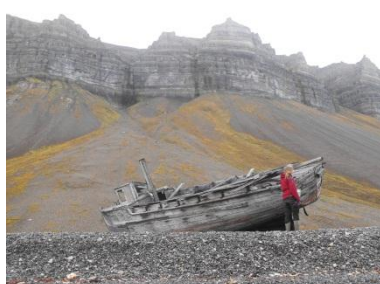
Figure 41 (above left): The loading boat (Sessford, August 2011).

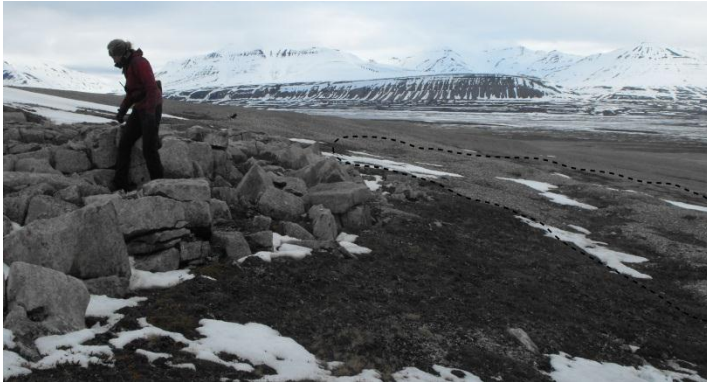
Figure 6: Hummocky beach on MT3, note the rounded boulders from mechanical weathering through wave action, and holes from chemical weathering (Sessford, June 2012).

weathering by water, though subsequently affected by periglacial and Aeolian processes (Figure 6). When observing the present day beach, hummocks and pits appear where the ice foot sits during the winter (Figure 7). Hummocks on MT2 and MT1 vary from those on MT3 and the present day beach by having a different morphological character in that many have higher ridges up-slope, have a curved backscarp and tend to run parallel to the shore (Figure 8). Pits on these terraces tend to be behind the ridges (upslope) and are elongated along the palaeo shore. A similar landform to the hummocks on MT2 and MT1 is found on the modern shore where an ice floe had been pushed up on shore during an extreme event in 1999 (Figure 9).

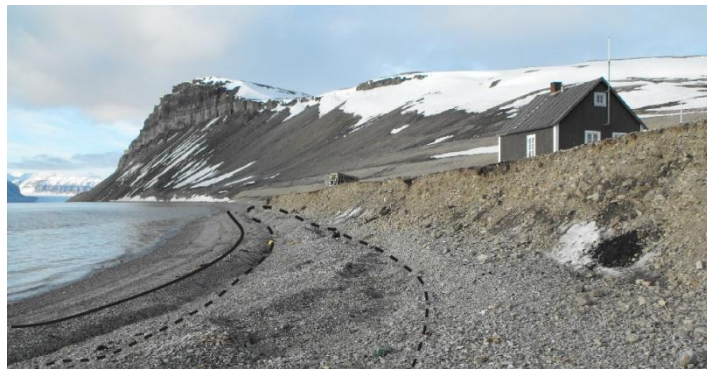
Figure 7: Modern beach reach as delineated by the solid line, and hummocks outlined by the dashed line (Sessford, June, 2012).

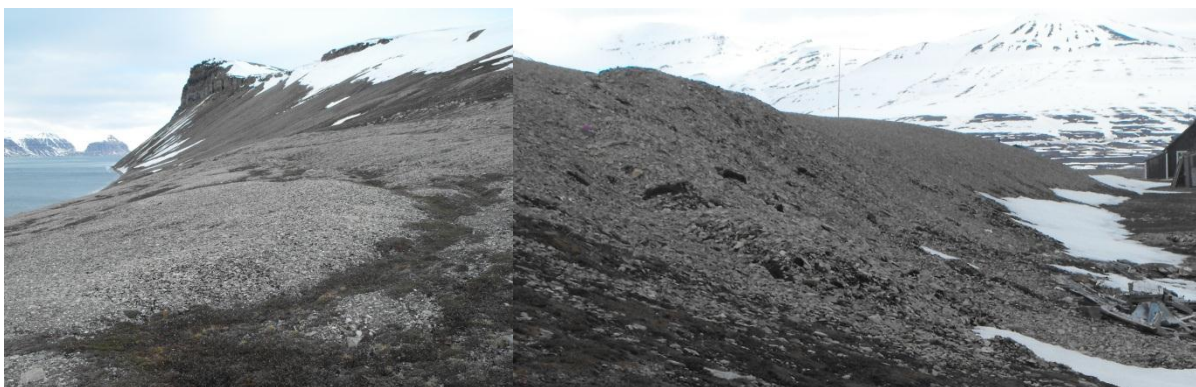
Figure 8 (left): Ice thrust ridge on MT3 during deposition of MT2 and cooler times within the Holocene (Sessford, June 2012).

Figure 9 (right): Modern ice thrust ridge (marked as deformation by ice in Map 1) (Sessford, June, 2012).

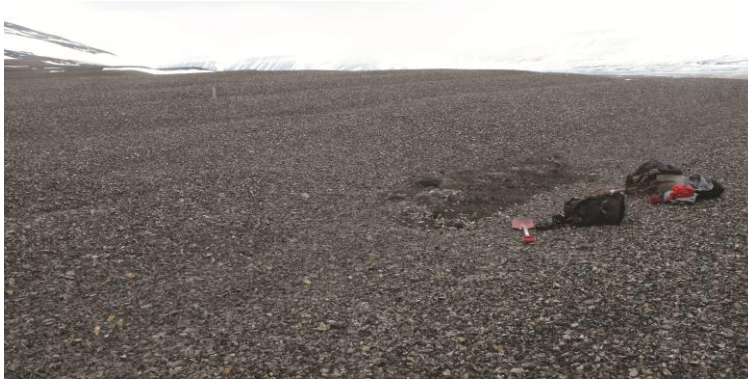
Figure 10: Fair weather beach ridges on MT3. The Black backpack dimensions are approximately 60 by 20 cm (Sessford, June 2012).

landward swale to be indicative of erosional stormy events in comparison to a gentle seaward slope associated with fair weather. Although beach ridges were not measured directly at Fredheim, one can see in Figure 10, from MT3 that beach ridges are relatively flat crested, have approximate amplitude of 30-50 cm and wavelengths approximately 5-6 m. The same trend is exemplified on MT4 and MT1. Ridges on MT2 are however, difficult to

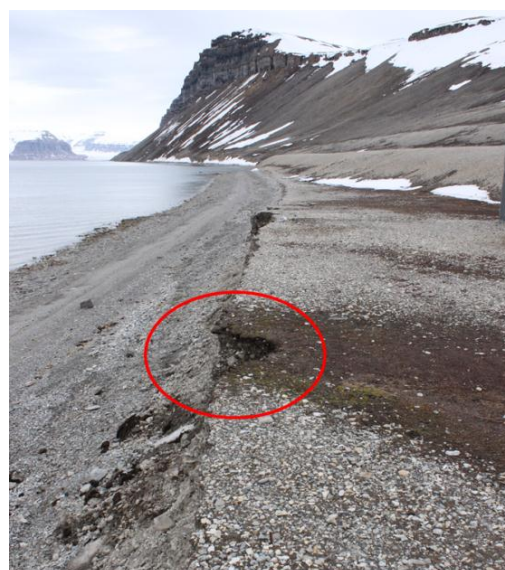
Figur 5 Sone med vannkanaler i jorden og utvasking.

Som tabellen over viser er det små variasjoner i erosjonsrater mellom erosjonskanten og det enkelte hus. Dette kan i hovedsak adresseres erosjonsmekanismene ved Fredheim. Det er tidligere hevdet at erosjonen i veldig sterk grad er knyttet til bølgeerosjon, men funn presentert i kapittel 0 viser at dette sannsynligvis ikke er tilfelle. Bølger er en medvirkende faktor, men i hovedsak gjelder dette som transportør av allerede eroderte masser. Hovedårsaken for erosjon kommer fra smelting og utrasing av permafrost jord der vannførende kanaler fra bakenforliggende områder er den største driveren. I disse kanalene er store deler av finmassene vasket ut og kanten mot sjøen blir dermed mer ustabil i dette området. Denne prosessen gjør at området mellom kanalene også blir mer ustabil på grunn av redusert sidestøtte.

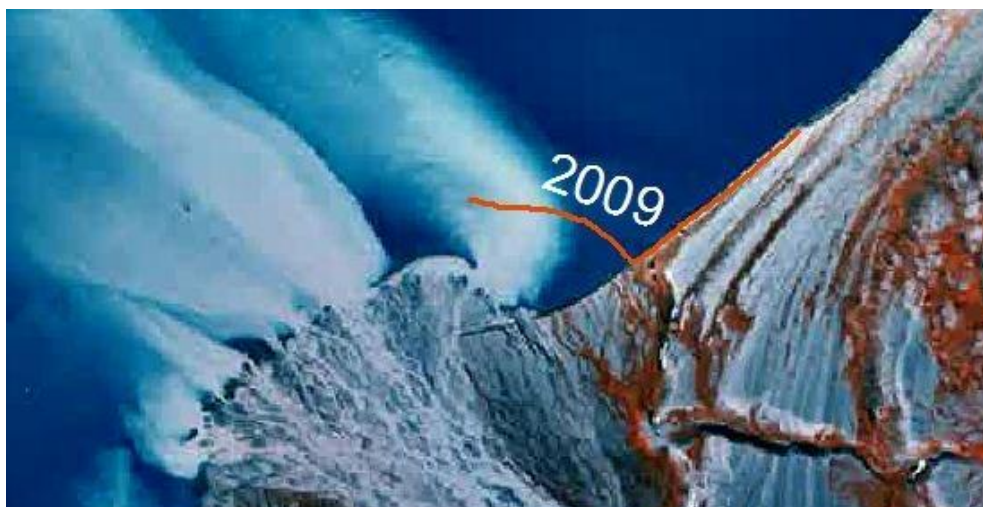
Figur 14 Aerial image from 1990 displaying sediment plume from Nøiselva carried by longshore drift toward the east. Orange line indicates extent of the delta and coastal cliff in 2009 as measured with DGPS. (Image adapted from Norsk Polarinstitutt image S90 2207).

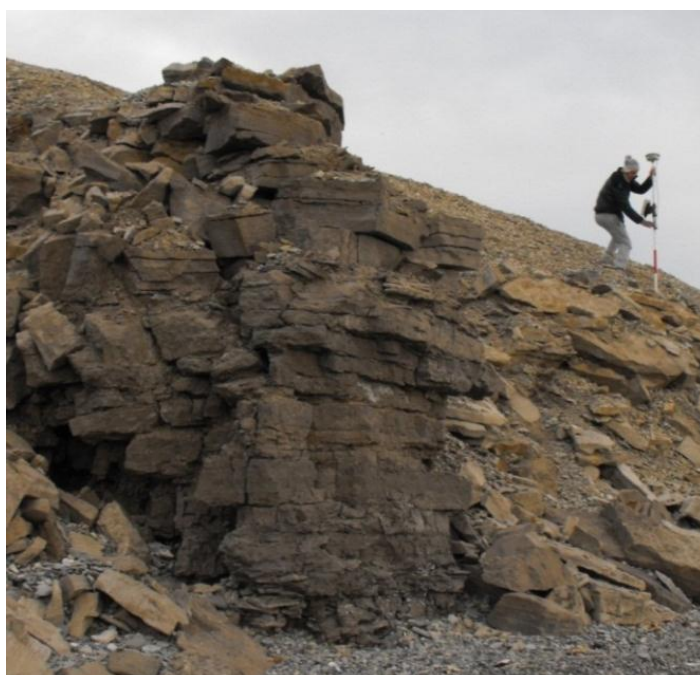
Figur 15 Bedrock outcrop at  $16^{\circ}56'2,214''$  E,  $78^{\circ}21'19,763''$  N, used for Q-system rock quality evaluation and samples C1 (detached from top of outcrop) and B2 (previously detached and found on beach below outcrop). (Photo: Sessford, July 2012).

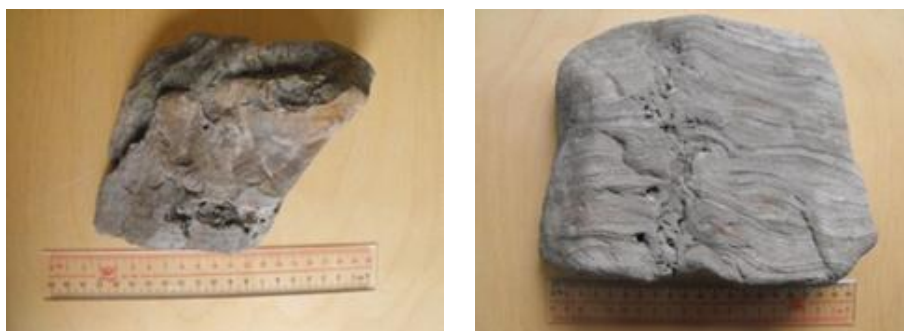
Figur 16 Samples C1 (left) and B2 (right)

Three bedrock samples have been collected from the beach and shore face; one, directly in front of the Villa (B1), one from on top of the outcrop shown in Figur 16 (C1) and the third from directly below the cliff face (B2) (Figur 16 and Figur 17). Bedrock is exposed again higher up on the marine terraces between MT1 and MT2 (Figur 13). This is a blockfield like exposure that is heavily frost shattered and broken. This trend continues with all exposures of reoccurring bedrock, each at the base of the slope between two terraces, and heavily weathered both chemically and mechanically (Figur 18 and 19). Bedrock samples are described in the next section.

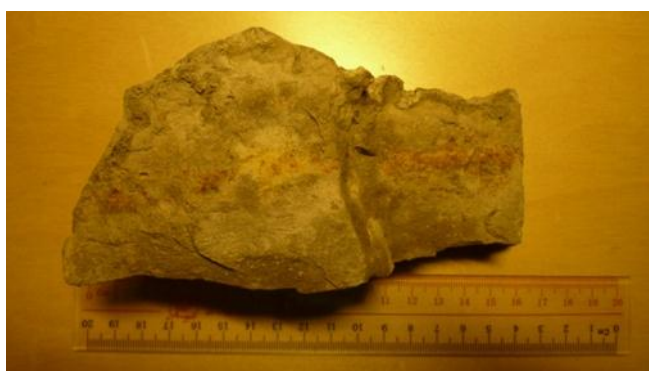
Figur 17 Sample B1

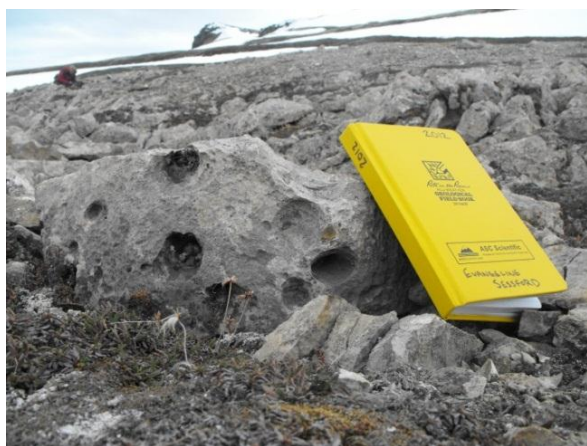
Figur 18 Chemical and mechanical weathering on bedrock outcrops on terraces (photo: Sessford 2012).

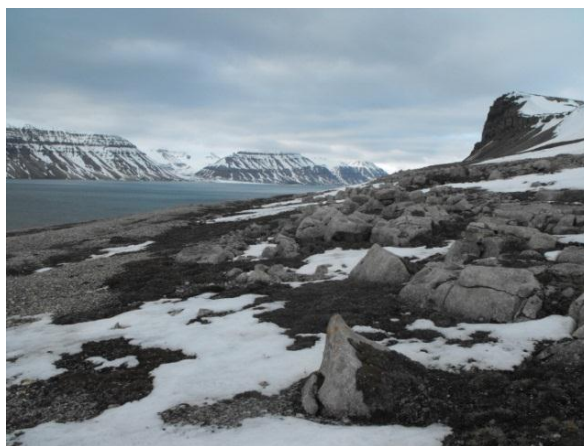
Figur 19 Bedrock outcropping on marine terrace (Photo: Sessford 2012).

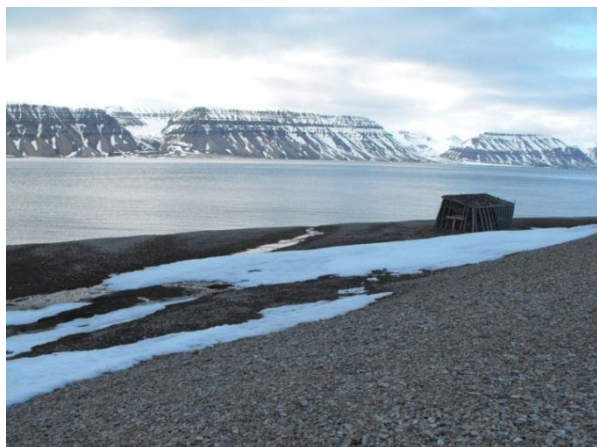
Figur 20 Spring melt-water flowing from snowpack along relict river and flowing over escarpment edge (Photo: Sessford, June 2012).

Fredheim itself lies on pre-recent fluvial sediments, meaning that the current river is not reworking sediment deposits. However, relict fluvial channels continue to be used as ground and melt water runoff channels during the spring and summer seasons (Figur 20 and 21). Several terrestrial samples have been taken from the escarpment and are described in the terrestrial section of this report. A present day pro-grading river energy dominated delta fed by the River Nøis lies directly to the west of Fredheim (Figur 13, 14 and 22). Within the last two decades the delta has extended approximately 125 m toward the east and in the process, protecting sections of the coastal escarpment (Guegan and Sessford in prep.). Sassenfjordenen is a fjord branch from the main Isfjorden system in Western Spitsbergen. Fjord sediment samples are described in the marine description section of this report.

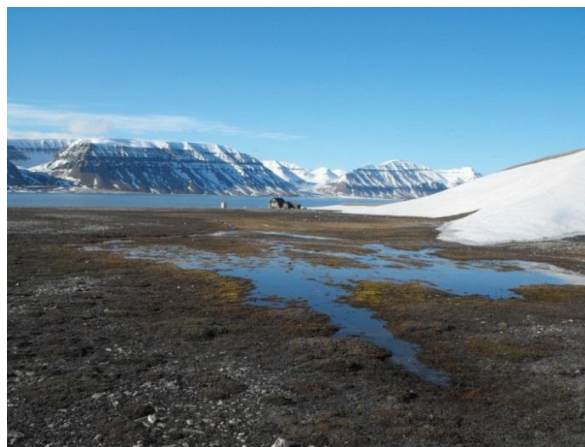
Figur 21 Surface water flowing from spring meltwater into bog and then out toward the fjord along vegetated relict river channel (Photo: Sessford, June 2012).

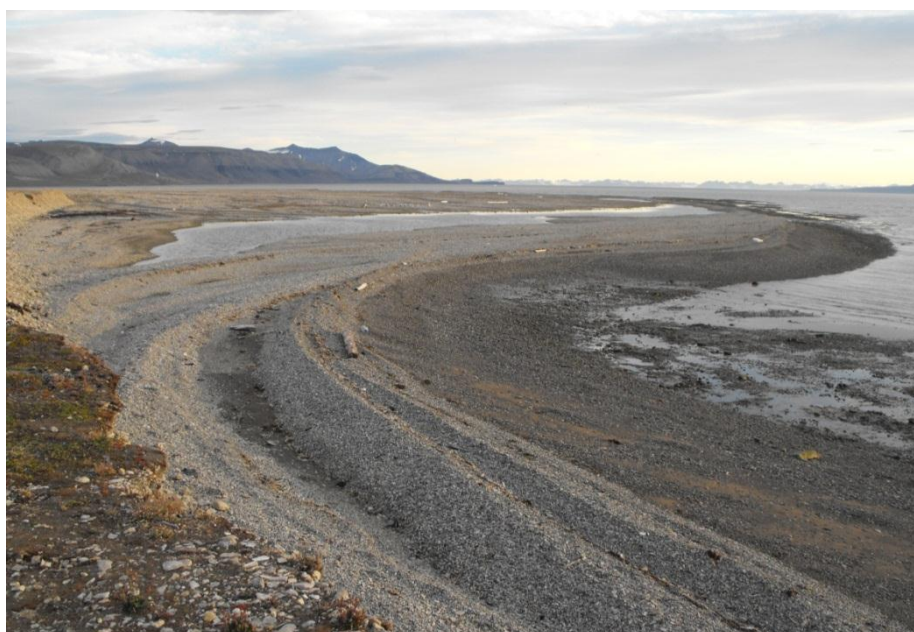
Figur 22 The Nøis River prograding delta has extended toward the east by approximately 125 metres in the last two decades (Photo: Sessford, August 2011).

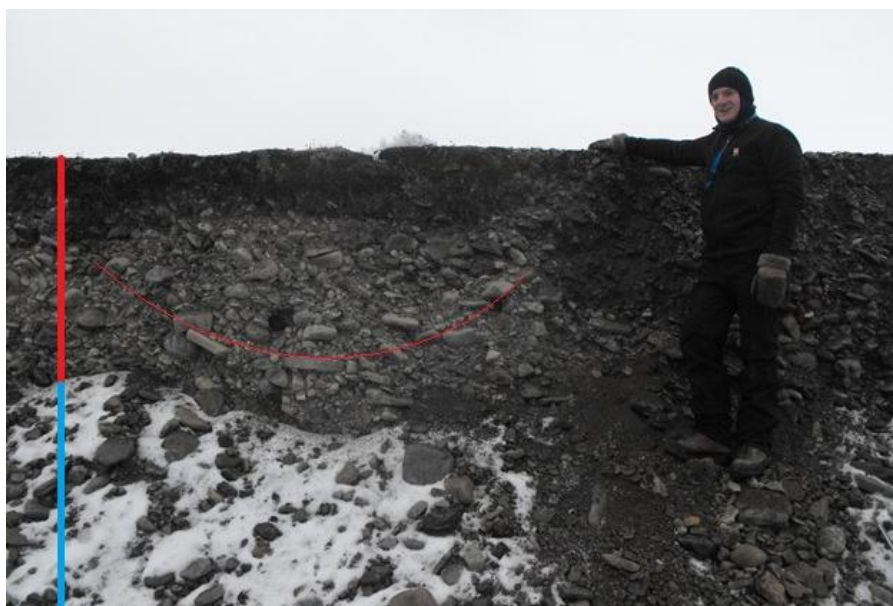
Figur 23                      Unconsolidated bimodal fluvial sediments that make up the coastal escarpment. Note the positioning of the stones indicated by the curved line in the cliff section (marked in red) which show a distinct channel deposition above which vegetation is growing. The blue section is scree deposits from erosion of the escarpment. (Photo: Sessford, October 2011).

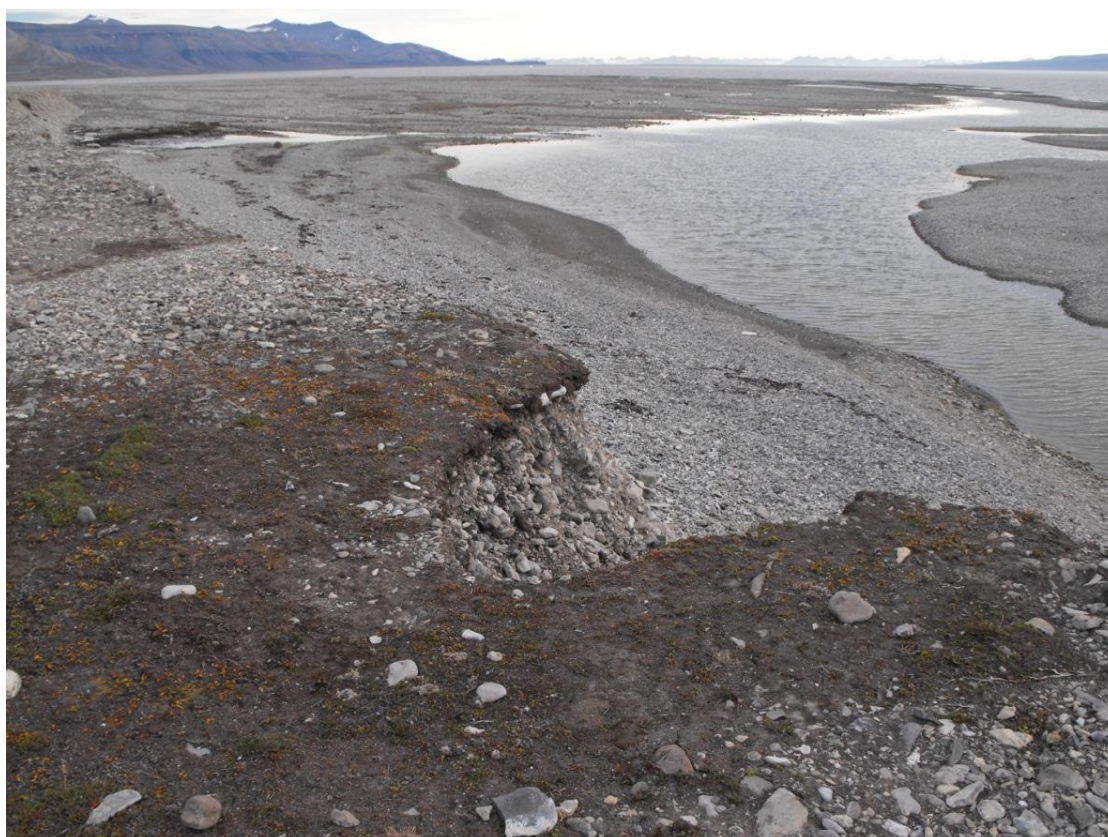
Figur 26 A relict channel that reaches the coastal escarpment and is undergoing higher erosion than inter-channel zones (un-vegetated). (Photo: Sessford, August 2011).

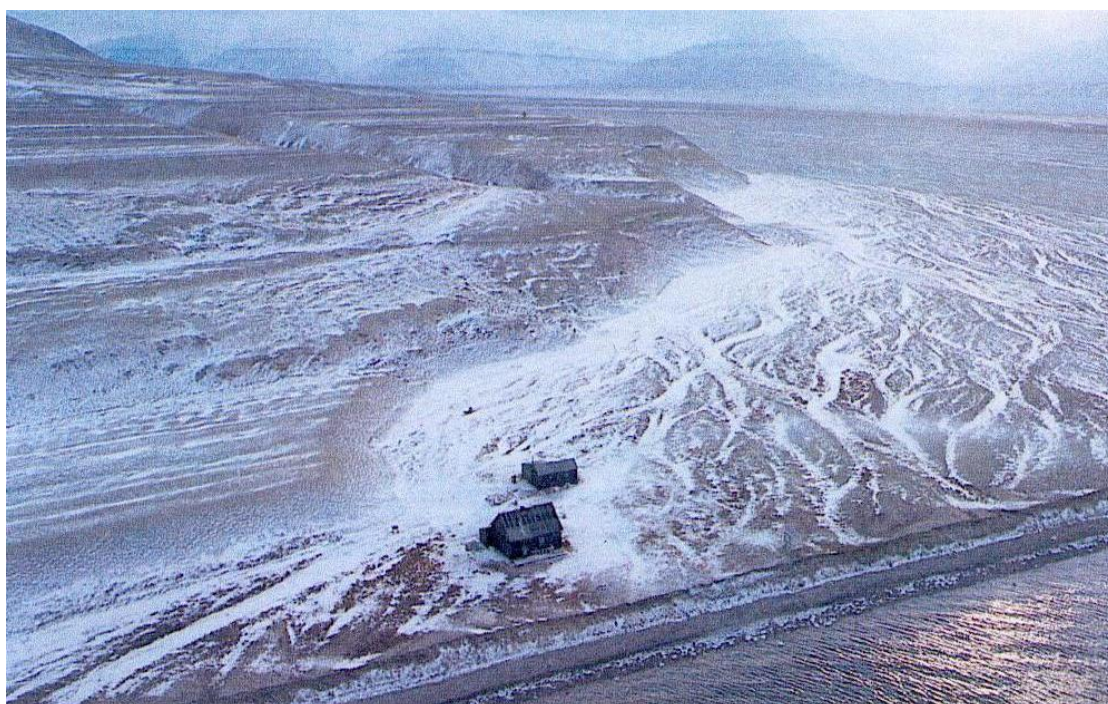
Figur 27 Oblique photo of Fredheim distinctly showing snow catchment areas in vegetated relict fluvial channels (Photo: retrieved from Pedersen Archives approx. date of image 1965).

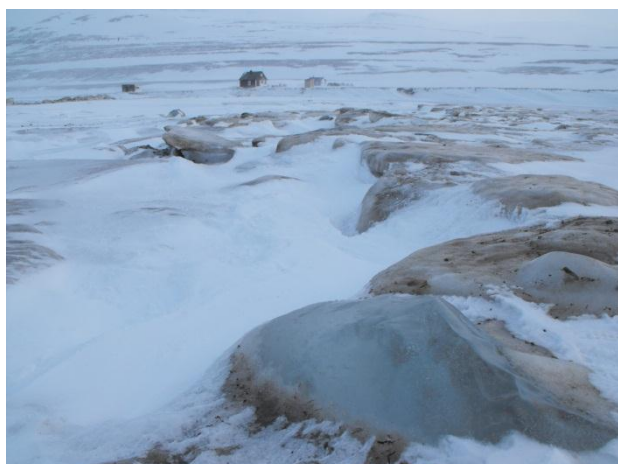
Figur 29 Sea and glacier ice pushed up onto delta from the east (photo taken approximately 30 m from delta edge) (Photo: Sessford, March 2012).

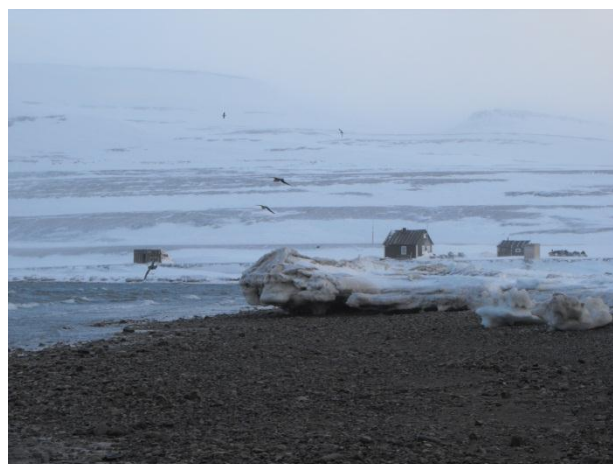
Figur 30 Ice piling up on edge of delta in front of Fredheim. Note the absence of sea ice in March (Photo: Sessford, 2012).

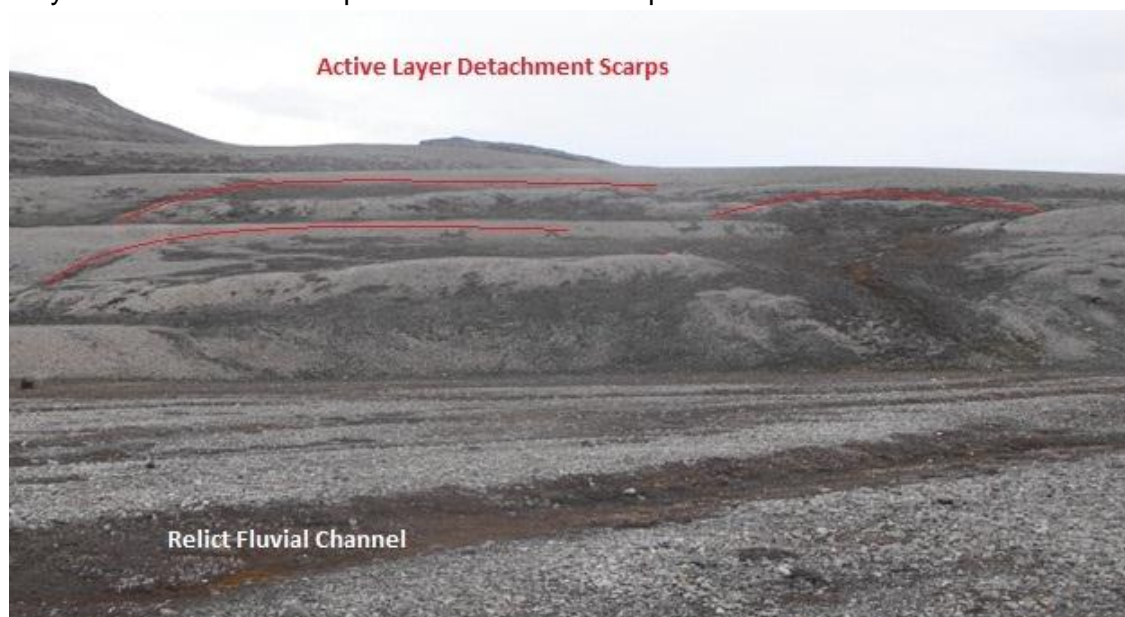
Figur 31 Active layer detachment slides behind buildings. Note channel like vegetated areas below scarps with high gelifluction and vegetation. (Photo: Sessford 2011).

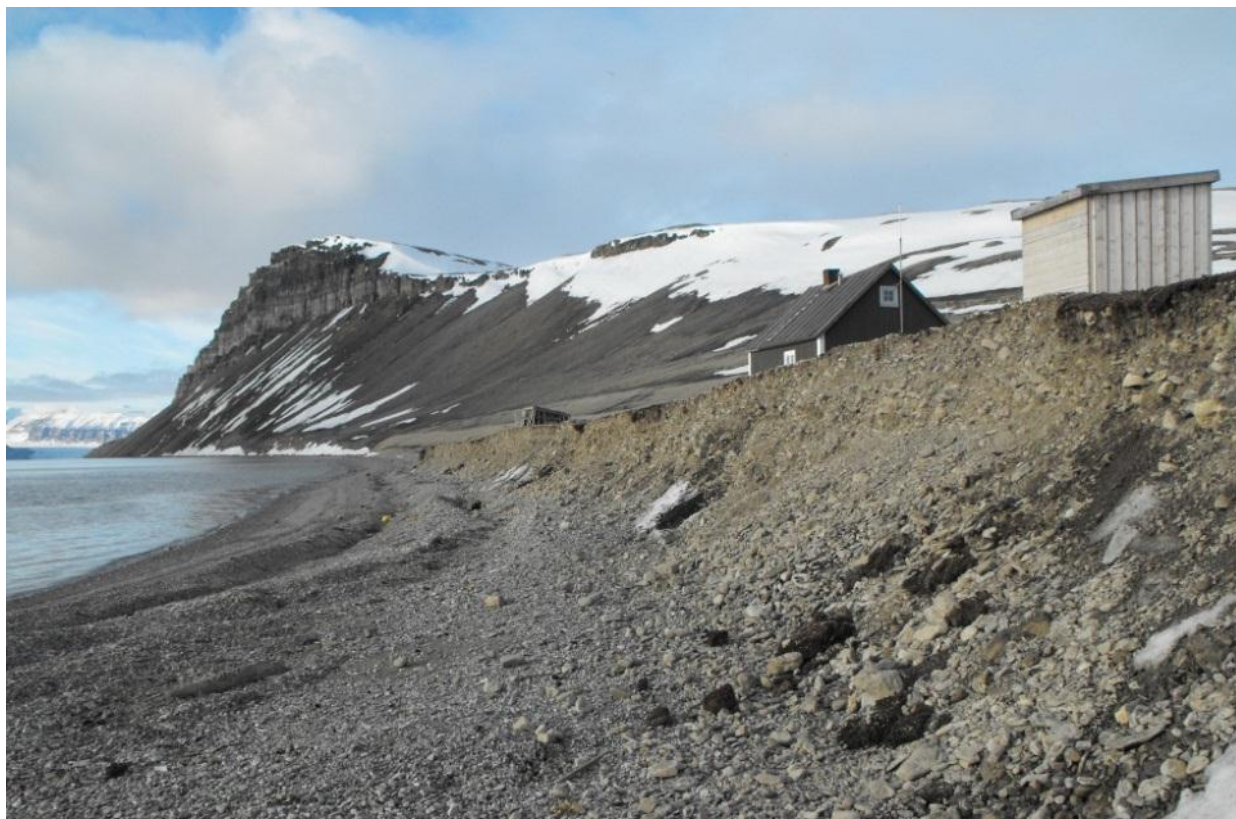
Figur 32 Waves do not hit coastal escarpment even at high tide. (Photo: Sessford, June 2012).

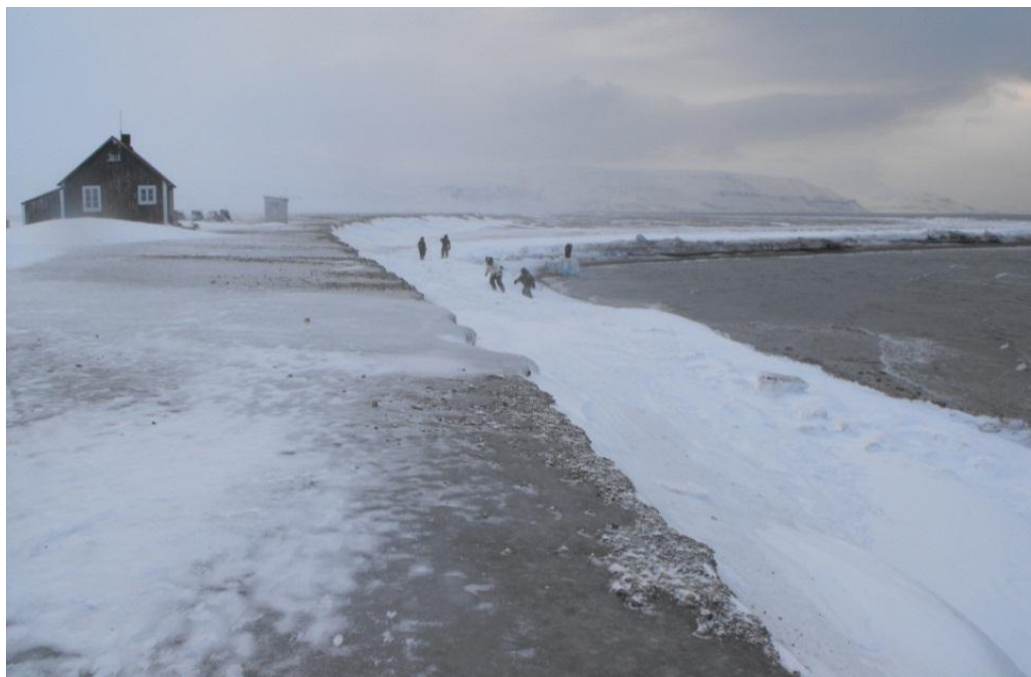
Figur 33 Ice foot attached to coastal escarpment possibly acting as an eroding agent through plucking of sediments. (Photo: Sessford March, 2012).

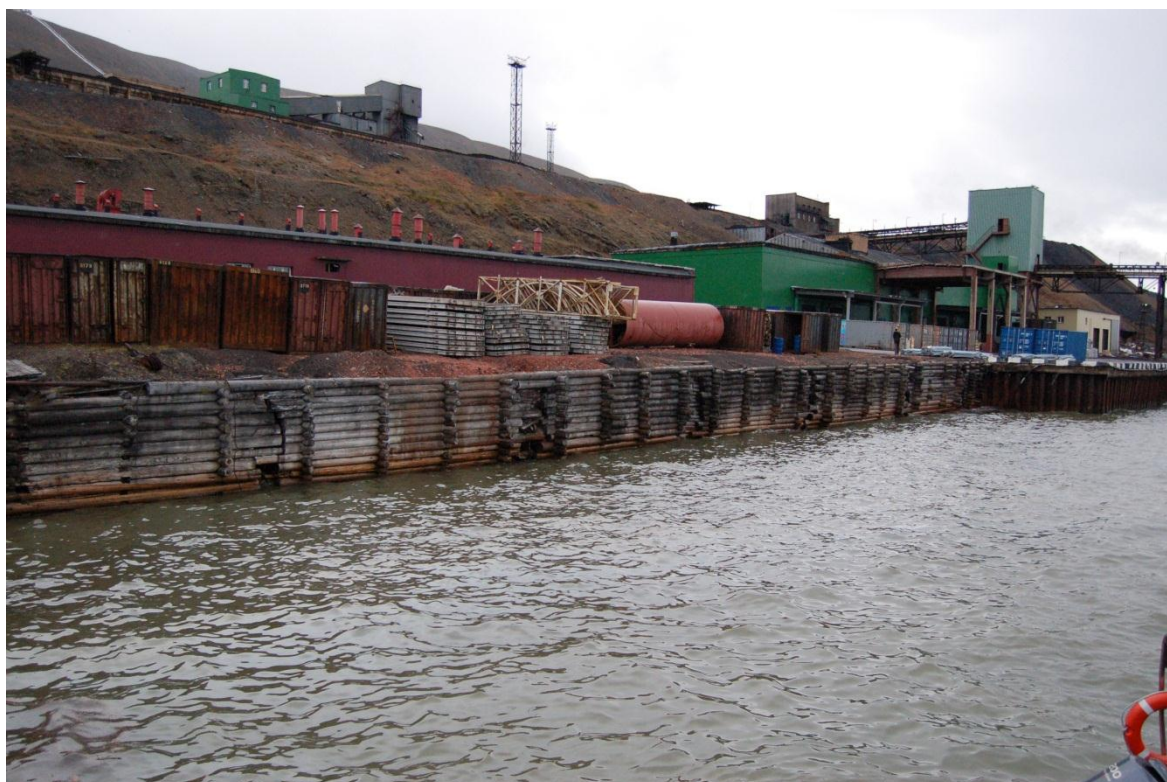
Figur 38 Erosjonssikring mellom to pirer i Barentsburg.

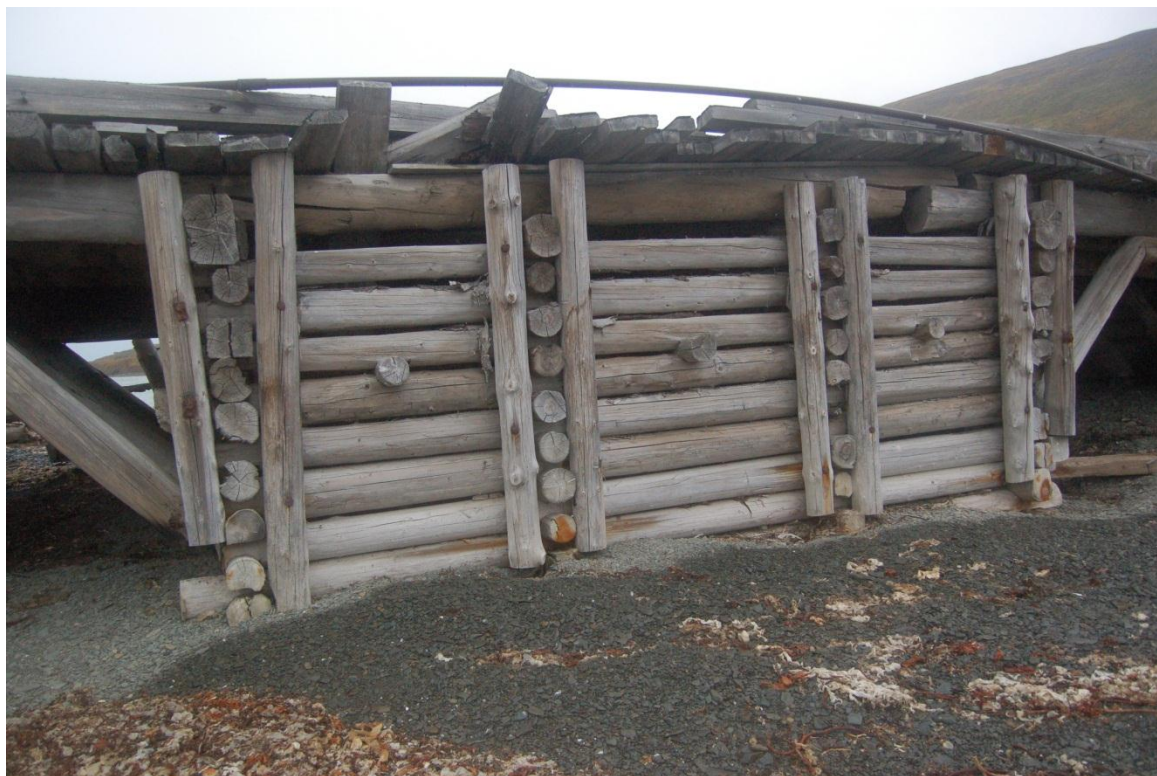
Figur 43      Motiv fra Coles Bay, nordligste pir.

De neste bildene som presenteres er utarbeidet av SINTEF Byggforsk ved landskapsarkitekt Bridget Thodesen. Det første alternativet tar utgangspunkt i en av senkekassene i Coles Bay, nordligste pir. Kassen er en del av brufundamentet og er et av de konstruksjonselementene som i særlig grad har tålt påkjenningene fra is og sjø gjennom mange tiår.
